2012 Annual Inspection and Maintenance Report for North Maybe Mine - East Mill Creek Restored Sediment Control Structure

Submitted by:
Nu-West Industries, Inc. and Nu-West Mining, Inc.

Submitted to:
United States Department of Agriculture, Forest Service

December 2012

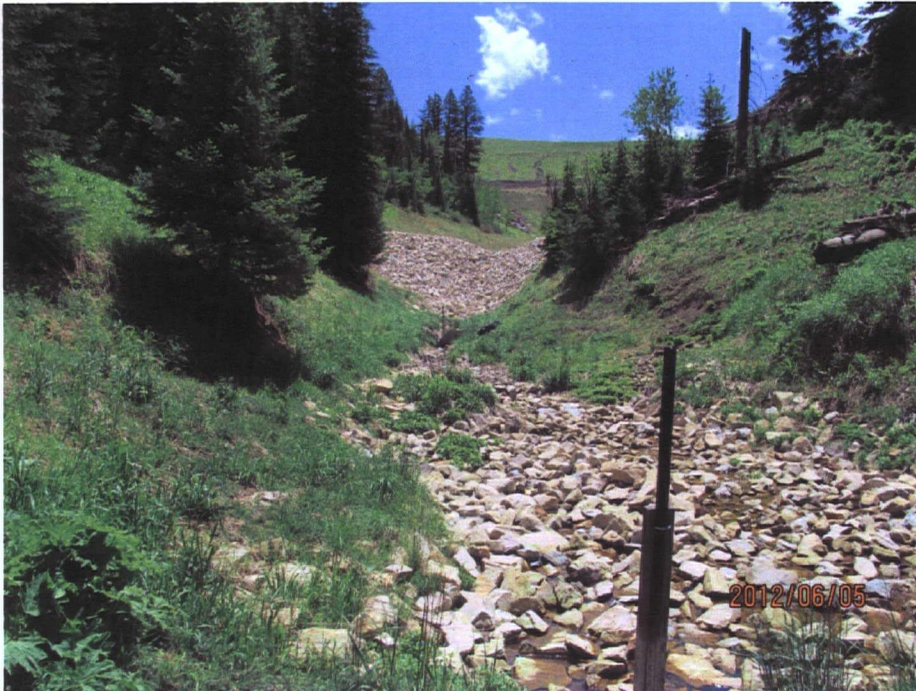
Photo taken looking south, showing the riprap lined channel below the sediment control structure and the lower weir.

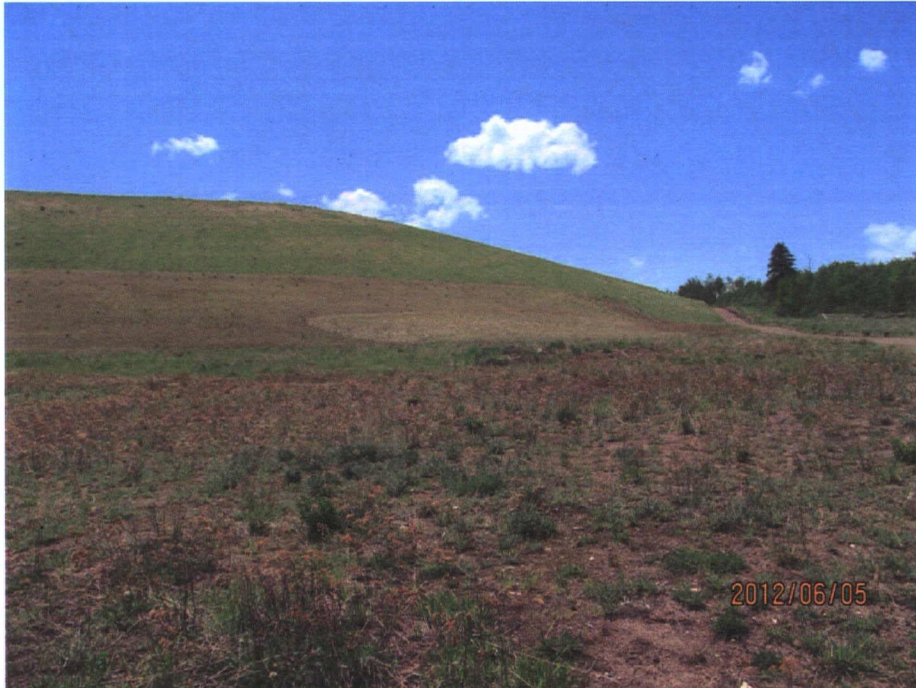
Photo taken looking south, showing the waste consolidation area.

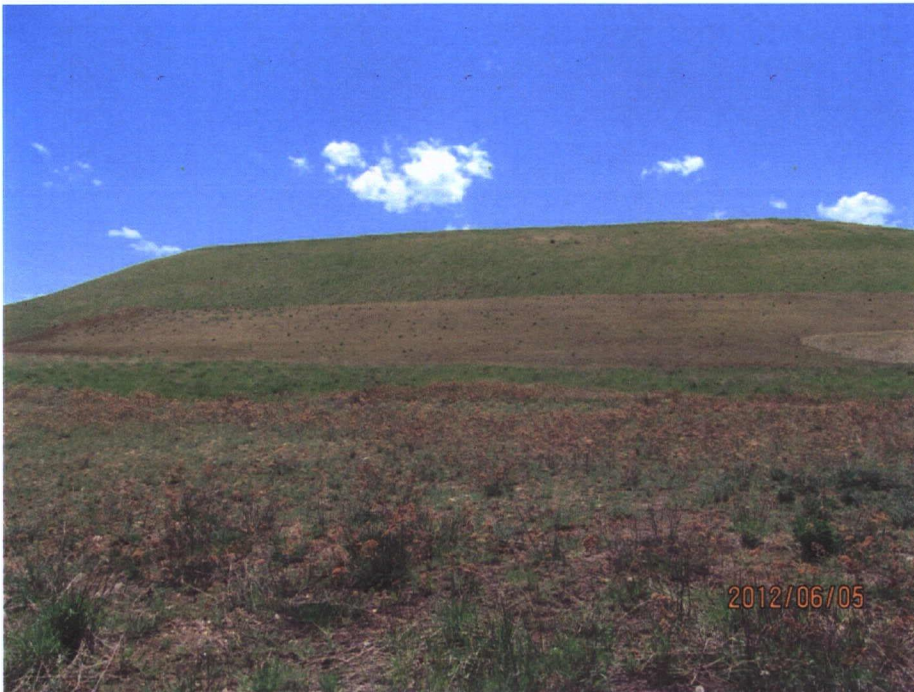
Photo taken looking southeast, showing the waste consolidation area. Area shows no evidence of erosion.

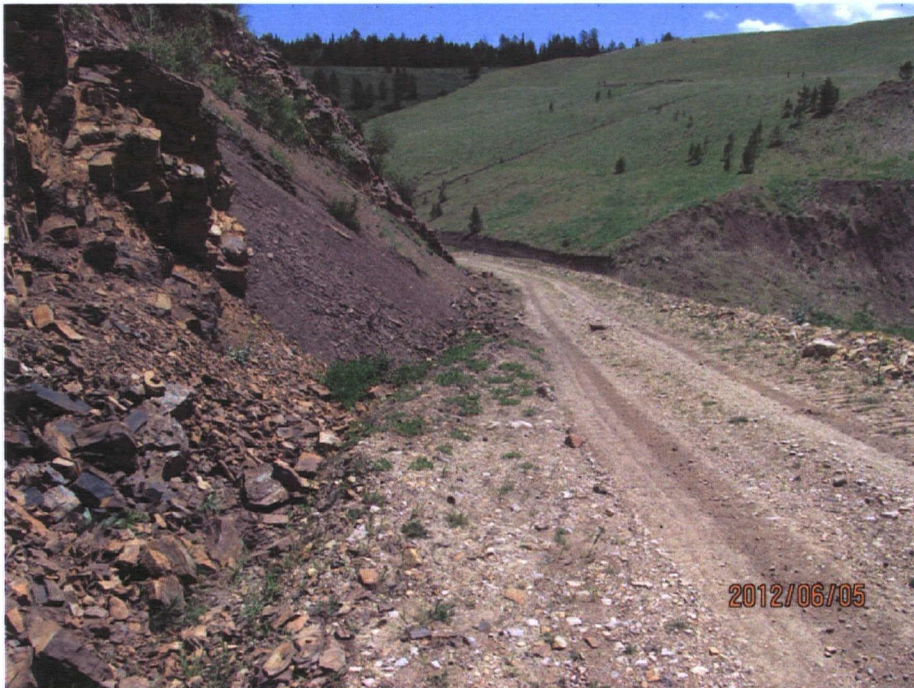
Photo taken looking east, showing the access road along the North Maybe Pit end wall. Some rock has rolled into the ditch but still maintains a flow line.

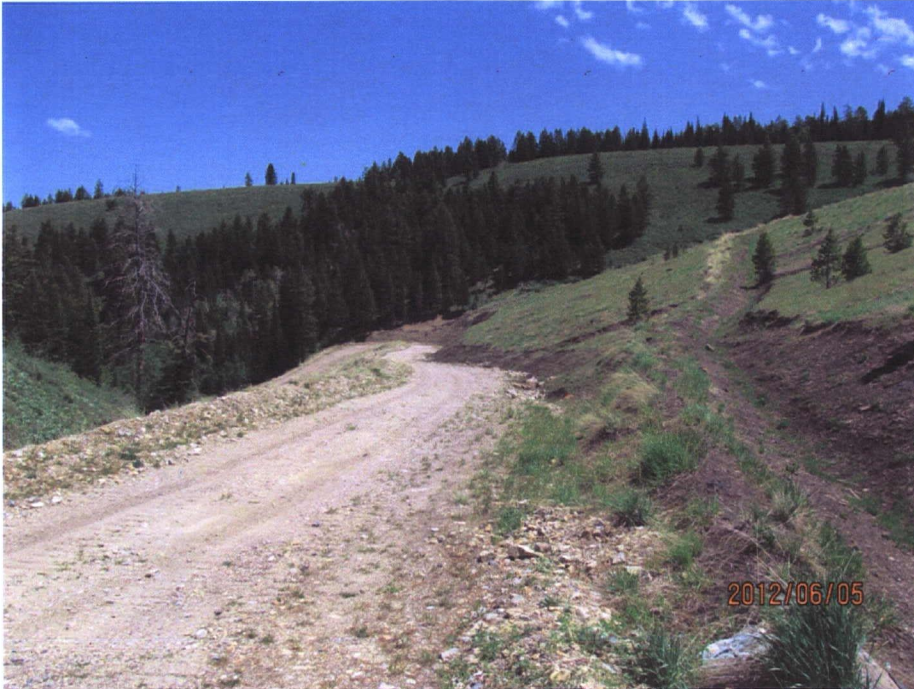
Photo taken looking east, showing the lower portion of the access road. Road and ditch are in good condition with no signs of erosion.

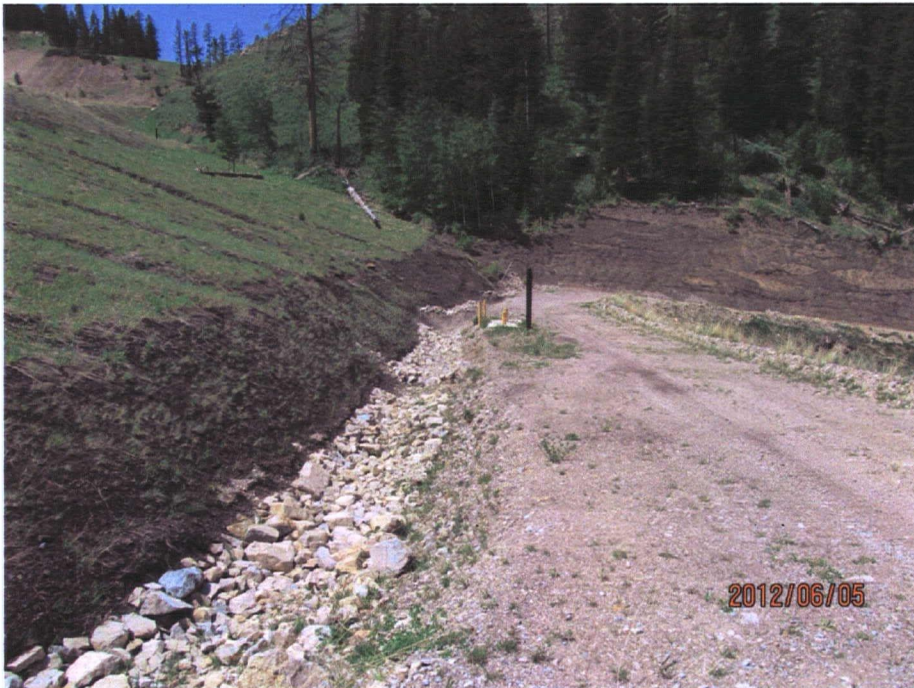
Photo taken looking west, showing the lower portion of the access road. The road and ditch are in good condition.

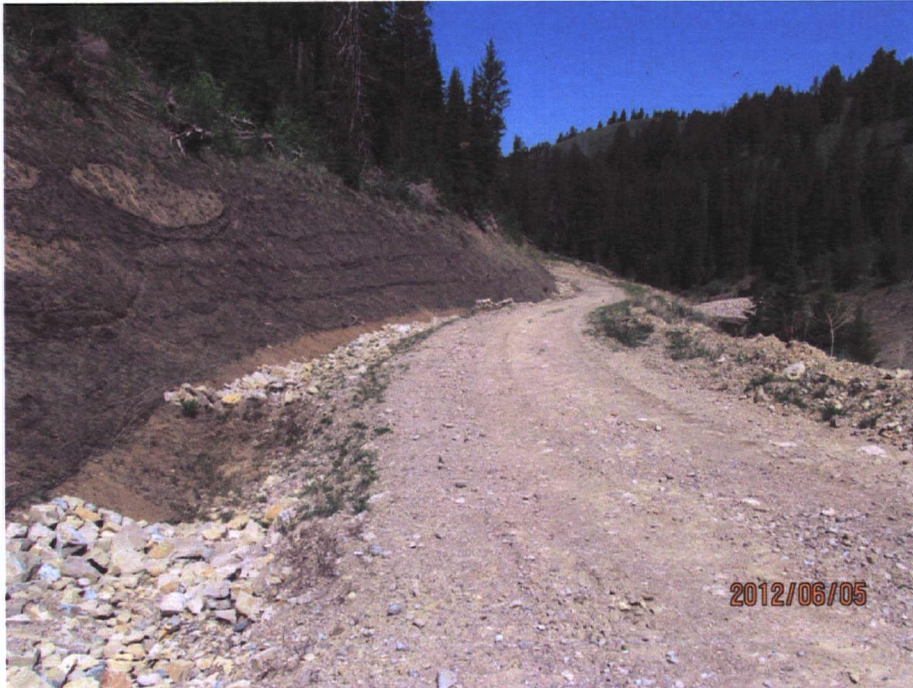
Photo taken looking north, showing the lower portion of the access road. The road and ditch are in good condition.

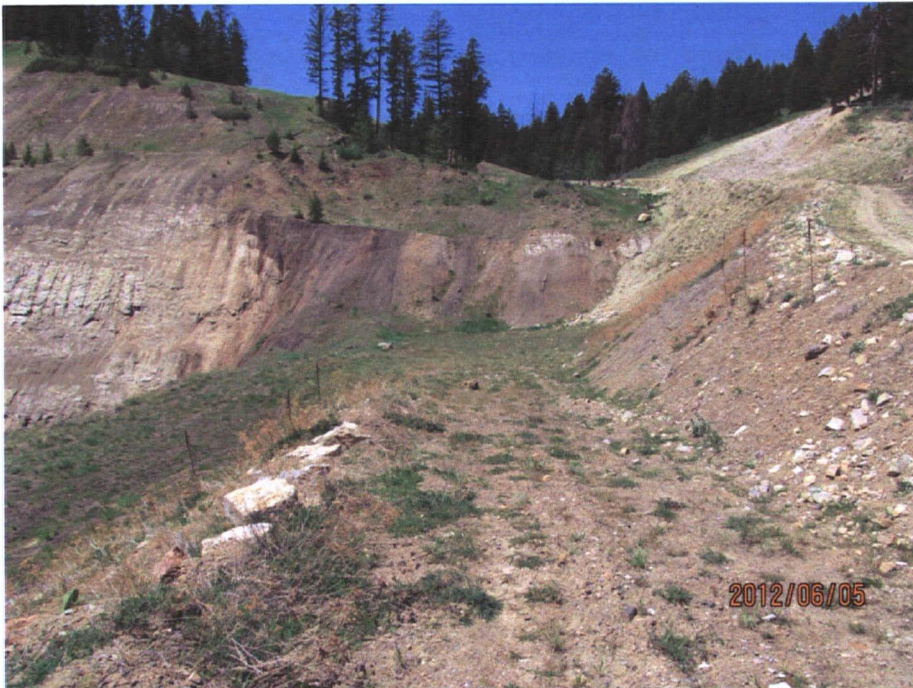
Photo taken looking west, showing the growth media borrow area located at the north end of the pit. This area is holding up well showing no signs of erosion and vegetation established.

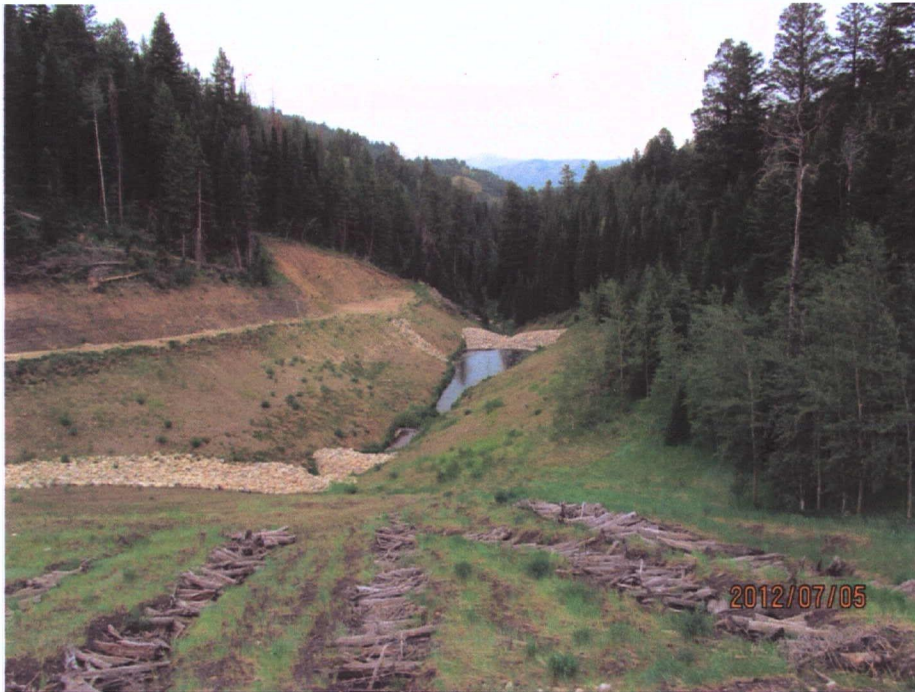
Photo taken looking north, showing the graded area surrounding the sediment pond, riprap below culvert outfalls, riprap energy dissipater, riprap toe berm, logs placed in rills on East Mill Dump and the sediment control structure. No evidence of erosion was observed in these areas and the vegetation is abundant.

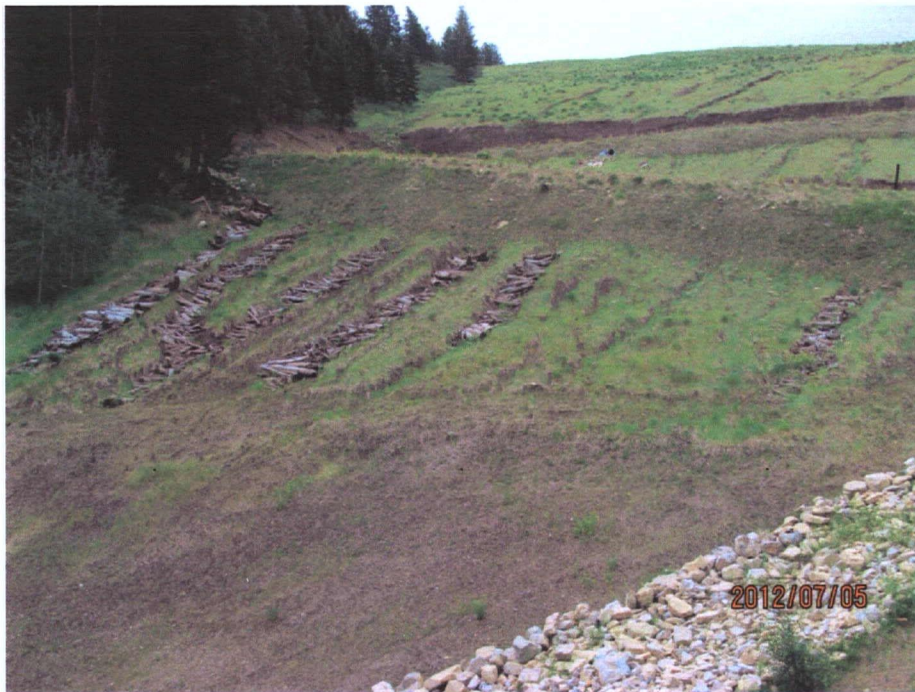
Photo taken looking southeast showing the logs in the rills on East Mill Dump and the riprap lined channel below the upper culvert. No evidence of erosion is present.

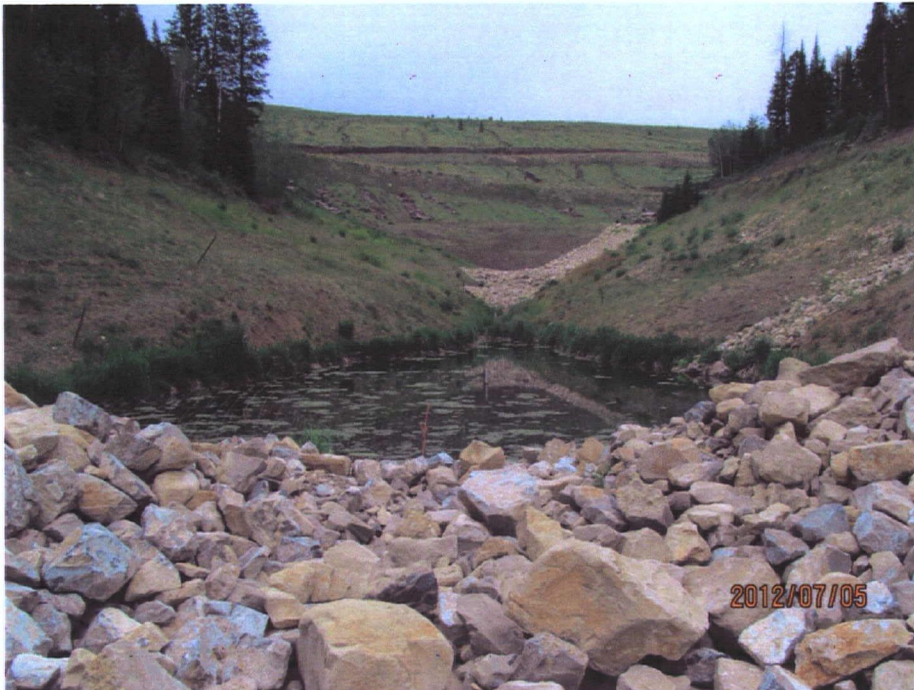
Photo taken looking south, showing the graded area surrounding the sediment pond, riprap below culvert outfalls, riprap energy dissipater, riprap toe berm, logs placed in rills on East Mill Dump and the sediment control structure. The area is in good condition with abundant vegetation.

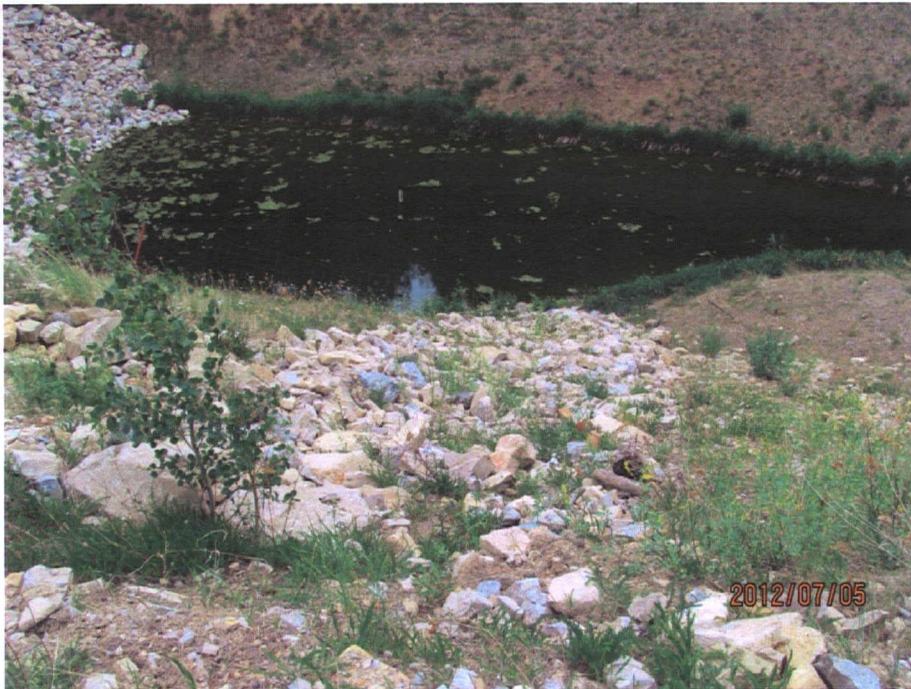
Photo taken looking east, showing the riprap lined channel below the lower culvert and the clarity of the sediment control pond.

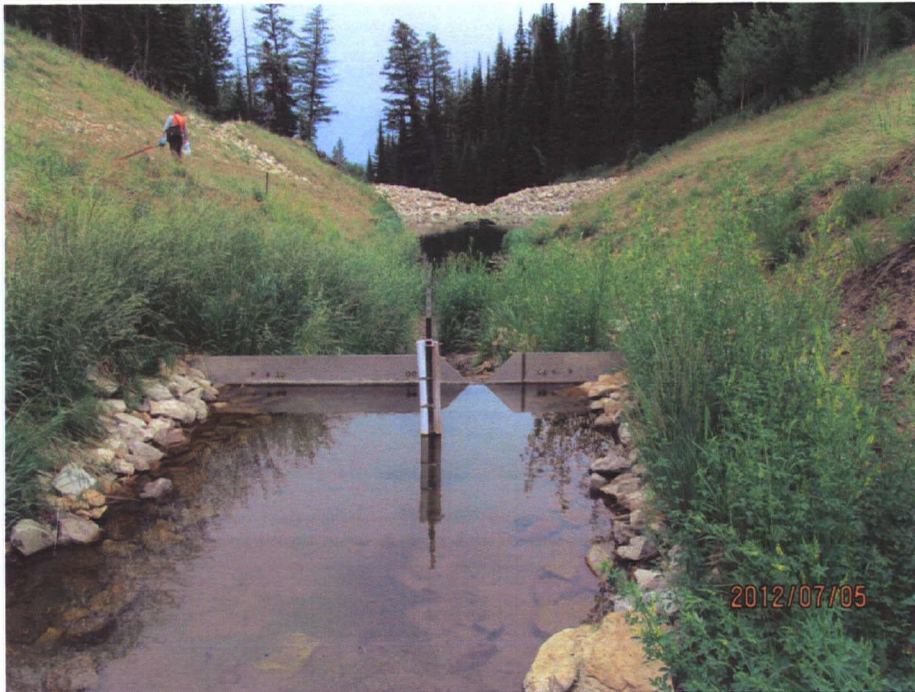
Photo taken looking north, showing the upper weir and the sediment control structure. No evidence of erosion is present and vegetation is well established along the channel.

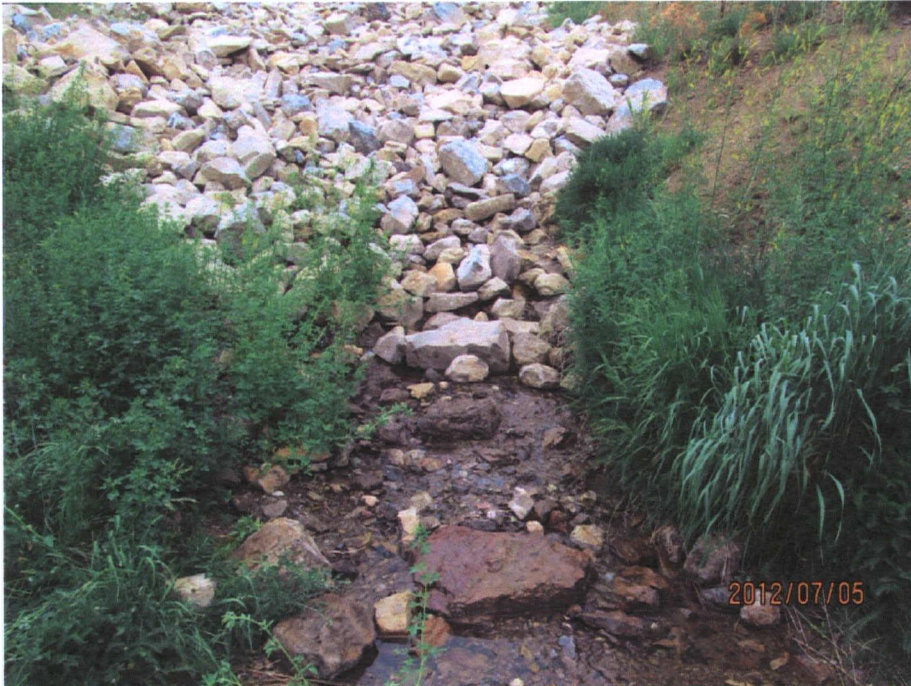
This photo is the toe of the riprap energy dissipater. Riprap armor is holding up well.

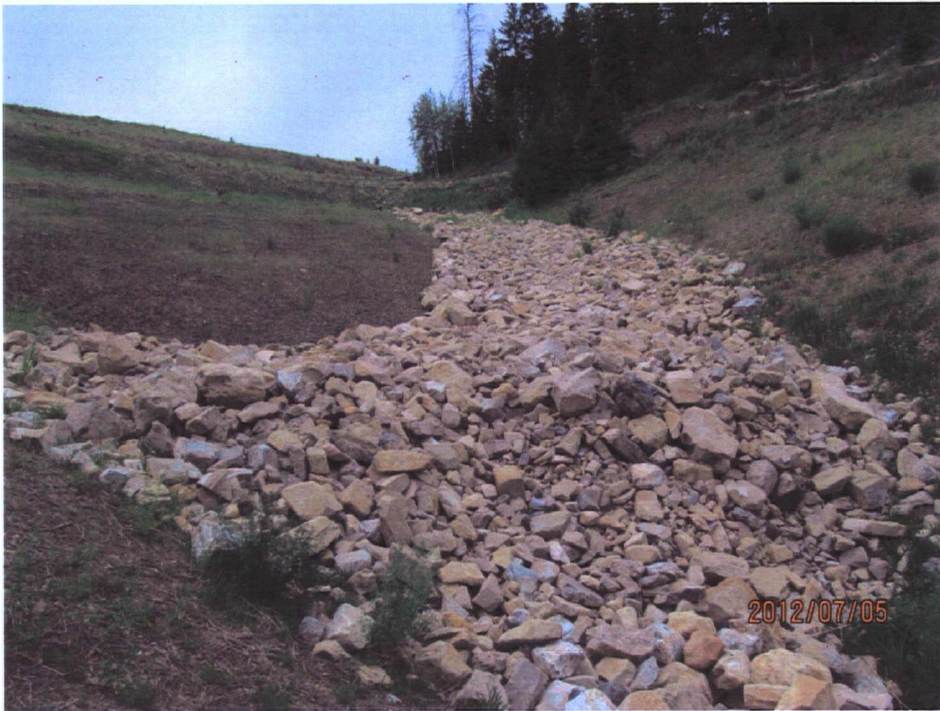
Photo taken looking south, showing the riprap lined channel below the upper culvert outfall. No sign of erosion is present.

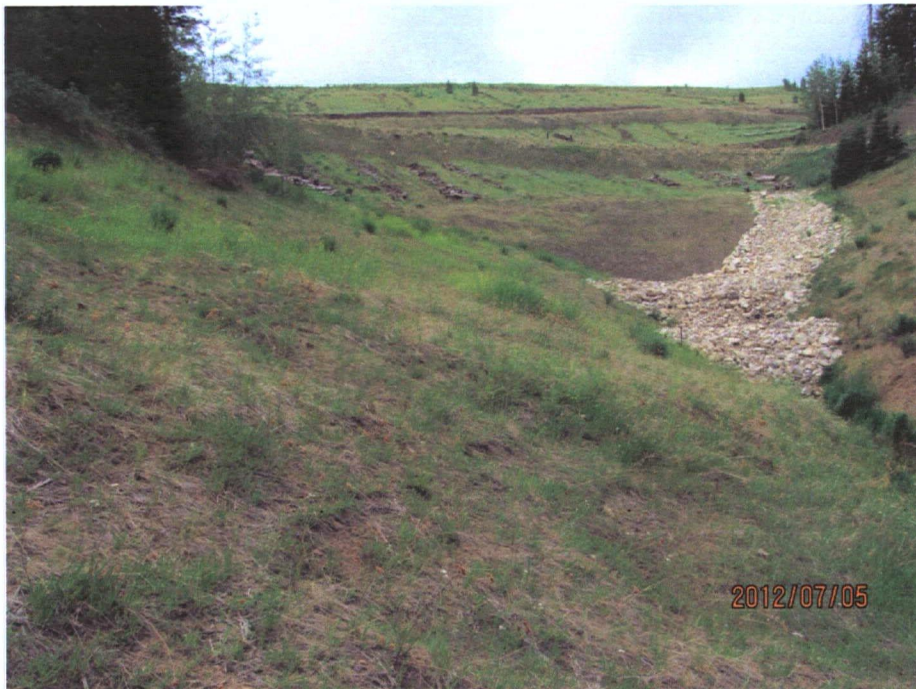
Photo taken looking south, showing the east side (west facing) slope of the graded area above the sediment control pond. Vegetation is well established on this slope with no signs of erosion occurring.

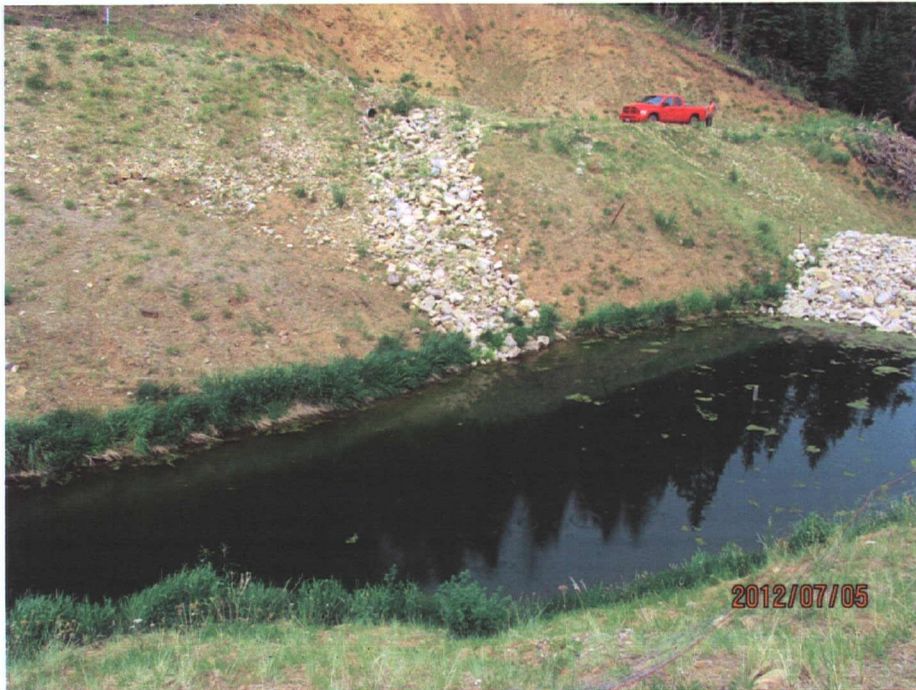
Photo taken looking west, showing the lower culvert outfall and clarity of the sediment control pond. Riprap armor below lower culvert outfall is doing a good job preventing scour and erosion.

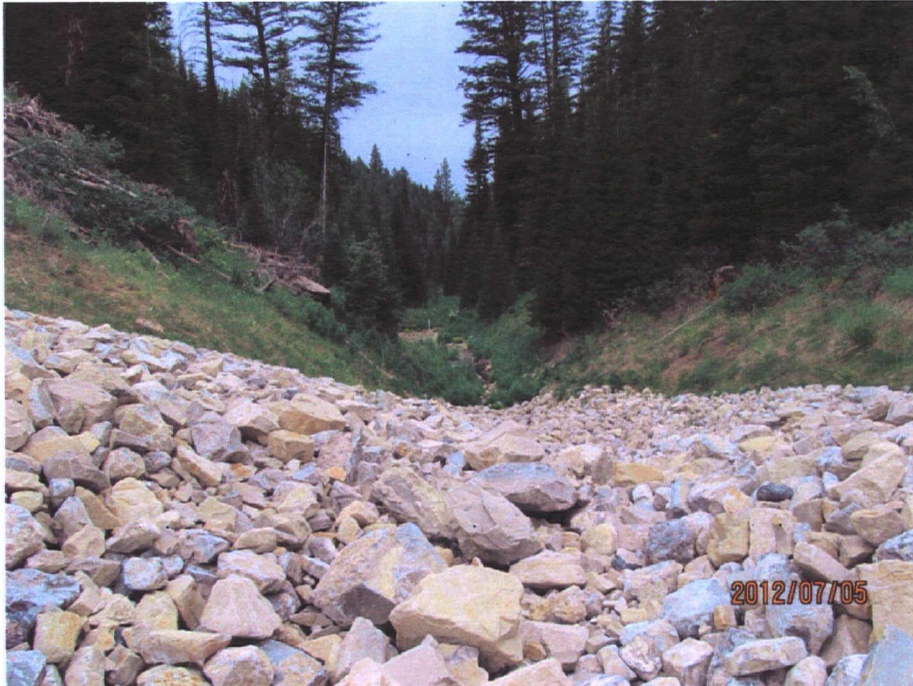
Photo taken looking north, from the top of the sediment control structure showing the lower weir and riprap lined channel below the sediment control structure. The vegetation is very abundant and the area is in good condition.

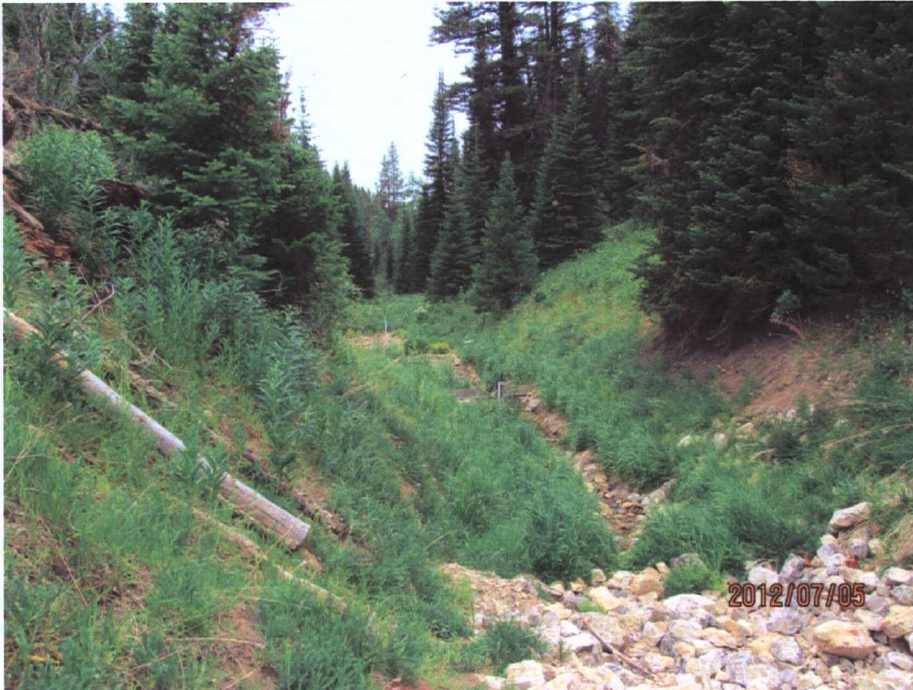
Photo taken looking north, showing the lower weir and riprap lined channel below the sediment control structure. This area is in good condition with vigorous vegetation established on side-slopes.

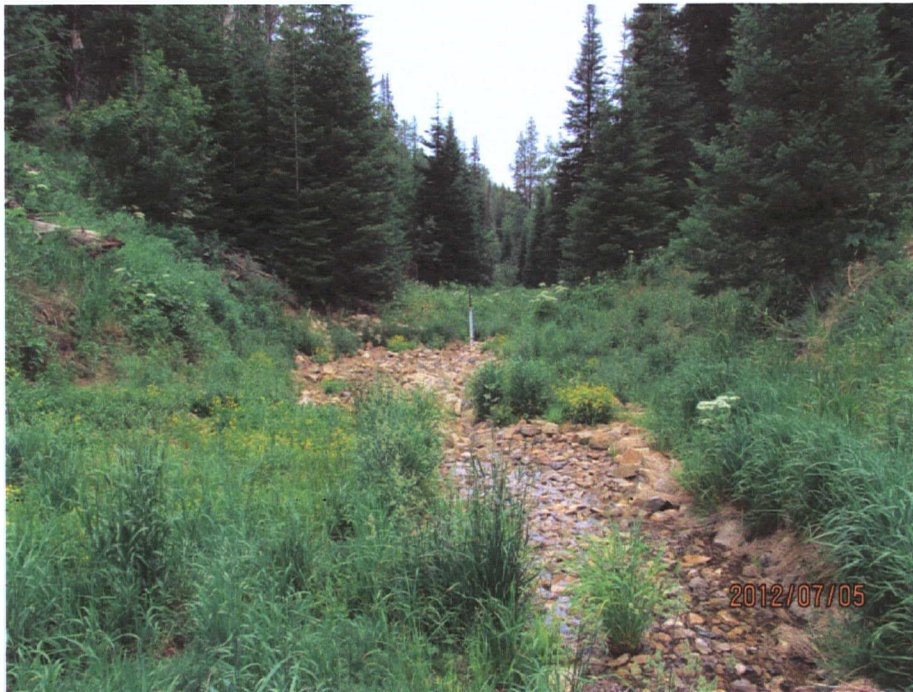
Photo taken looking north, showing the riprap lined channel below the lower weir. This area is well vegetated and stable.

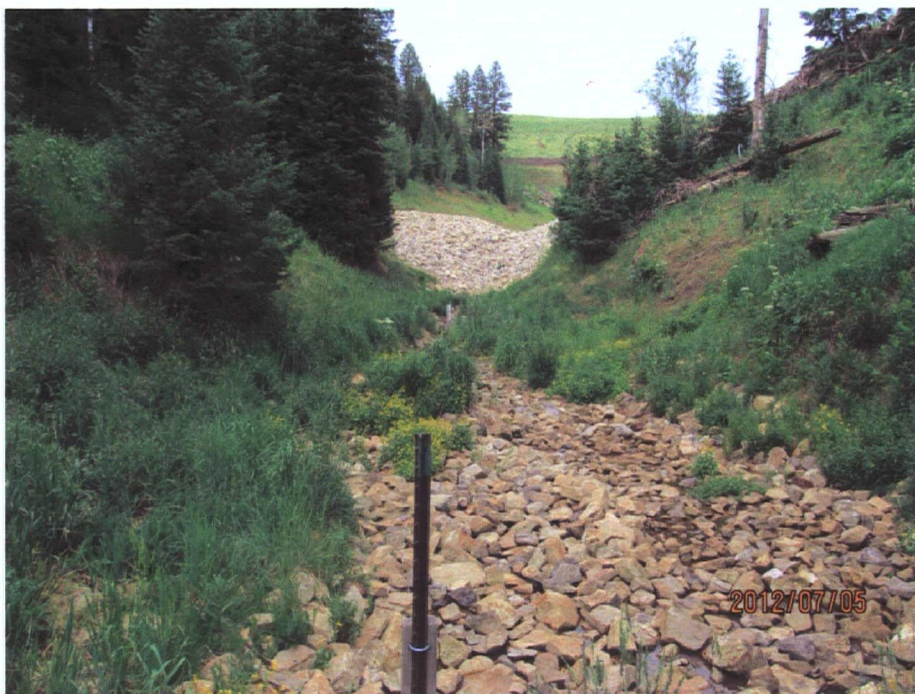
Photo taken looking south, showing the riprap lined channel below the sediment control structure and the lower weir.

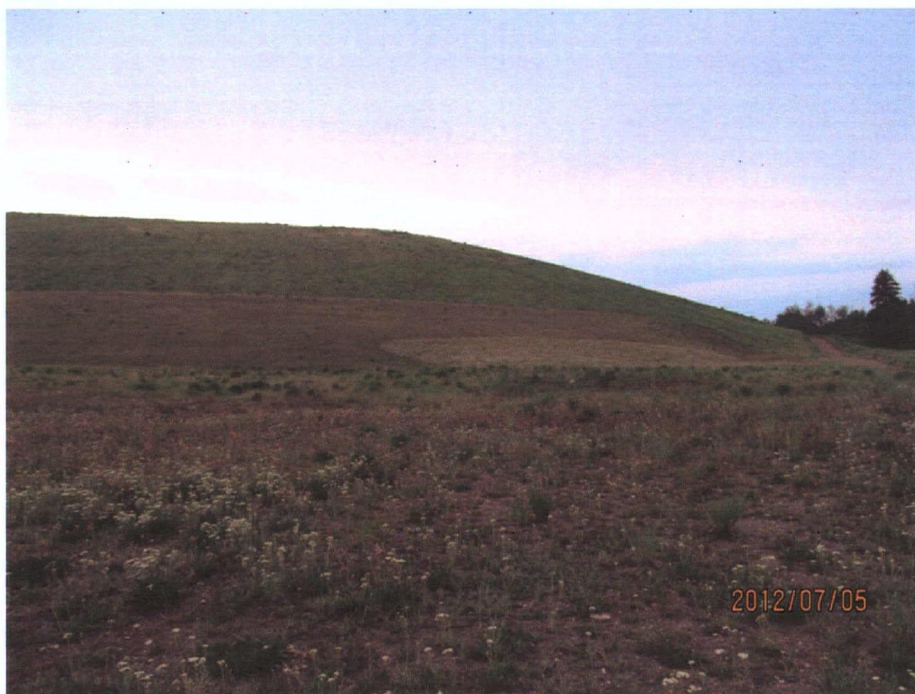
Photo taken looking south, showing the waste consolidation area. Vegetation has established and there is no sign of erosion.

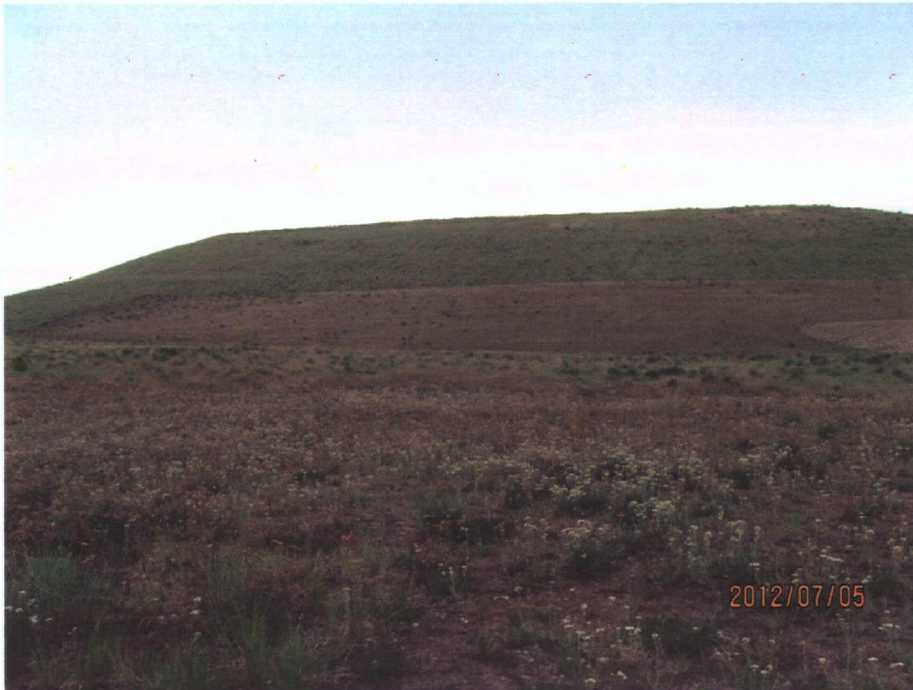
Photo taken looking southeast, showing the waste consolidation area. Area shows no evidence of erosion with abundant vegetation.

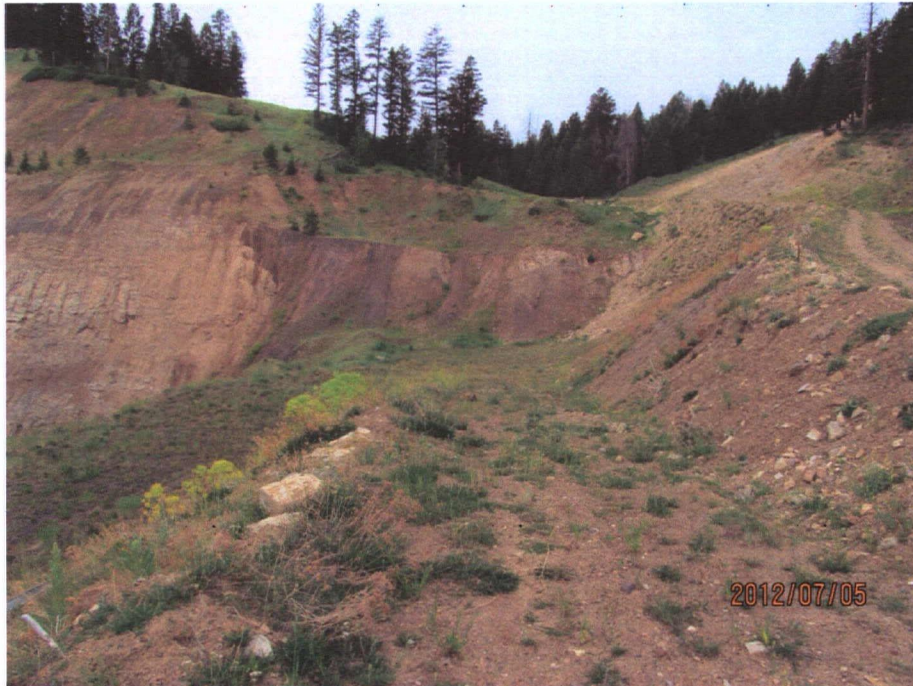
Photo taken looking west, showing the growth media borrow area located at the north end of the pit. This area is holding up well showing no signs of erosion and vegetation becoming established.

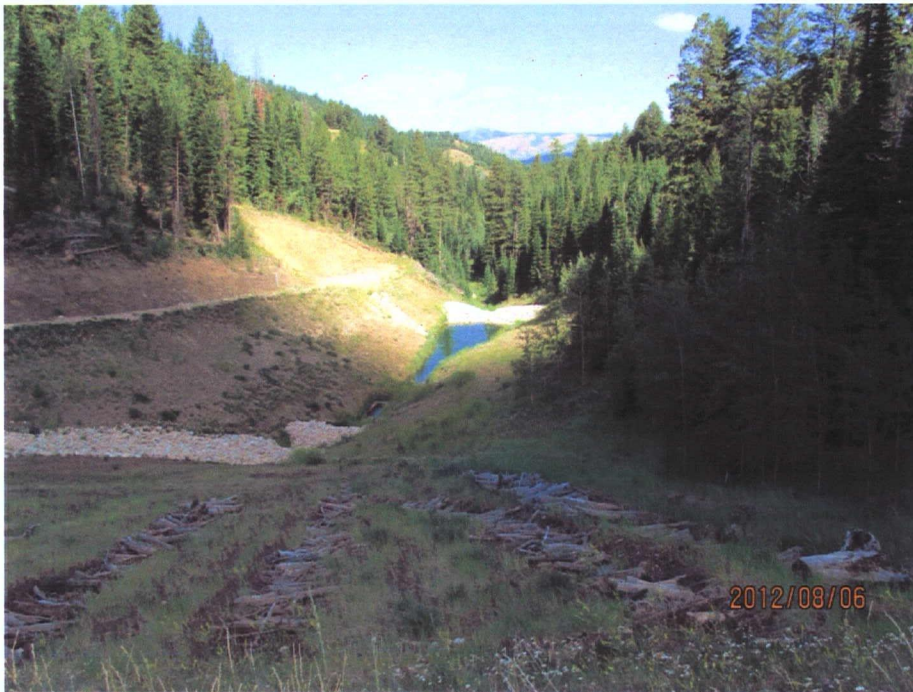
Photo taken looking north, showing the graded area surrounding the sediment pond, riprap below culvert outfalls, riprap energy dissipater, riprap toe berm, logs placed in rills on East Mill Dump and the sediment control structure. No evidence of erosion was observed in these areas and the vegetation is abundant.

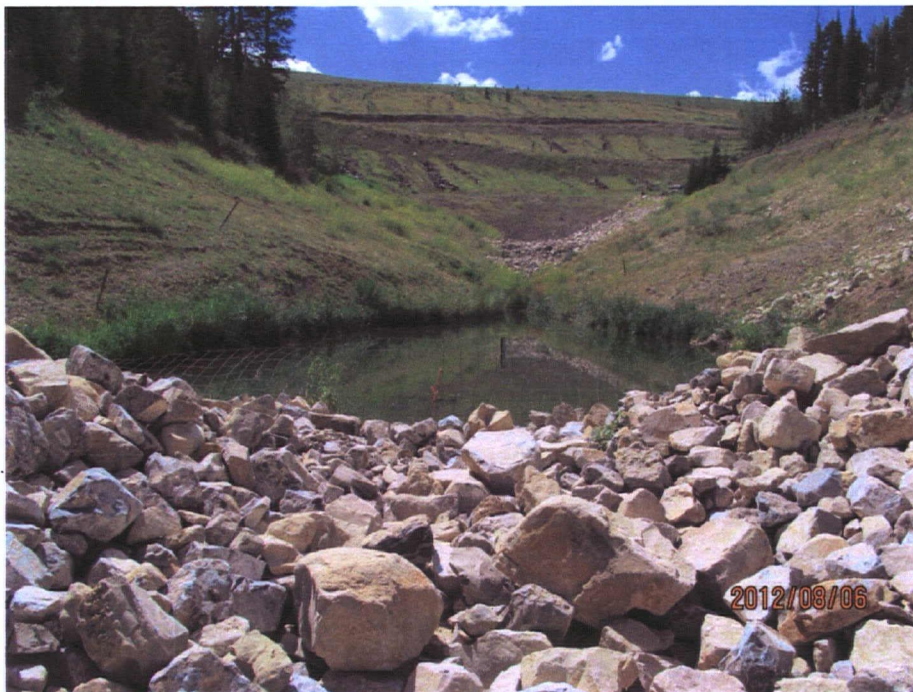
Photo taken looking south, showing the graded area surrounding the sediment pond, riprap below culvert outfalls, riprap energy dissipater, riprap toe berm, logs placed in rills on East Mill Dump and the sediment control structure.

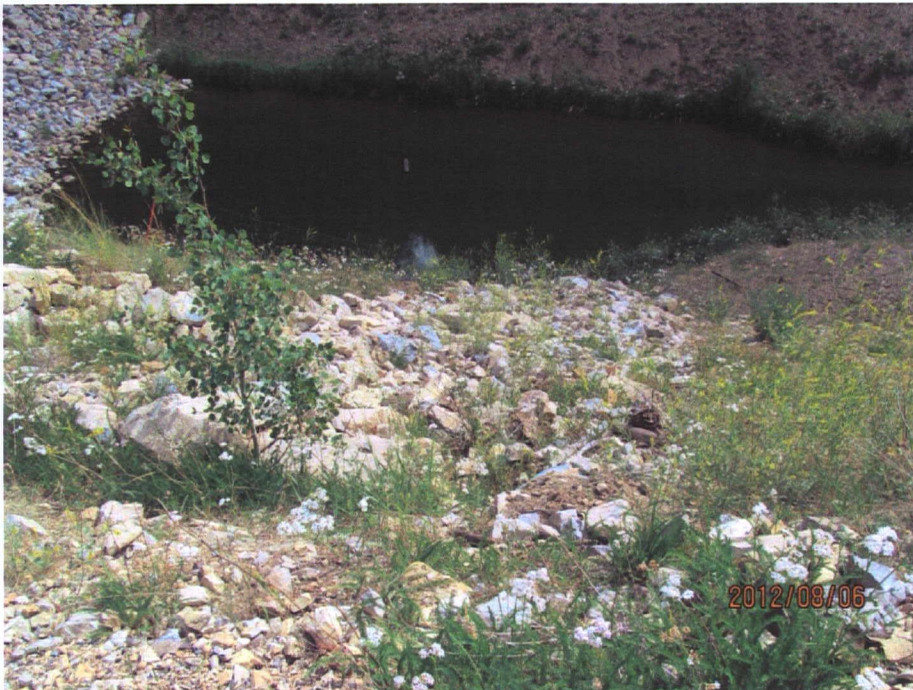
Photo taken looking east, showing the lower culvert outfall and the clarity of the sediment control pond.

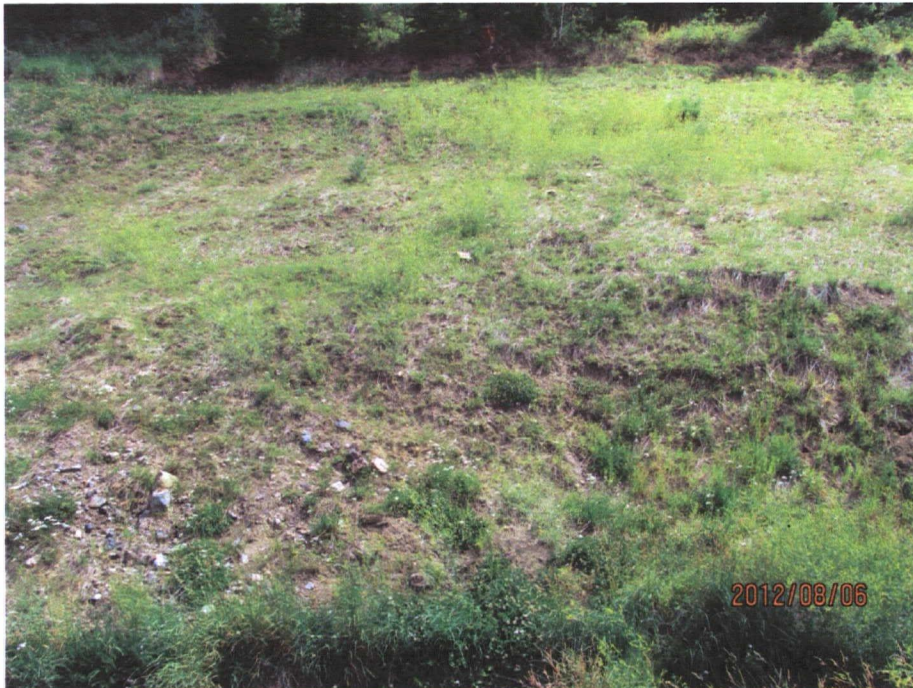
Photo taken looking east, showing the vegetation cover on the east slope of the graded area above the sediment control pond.

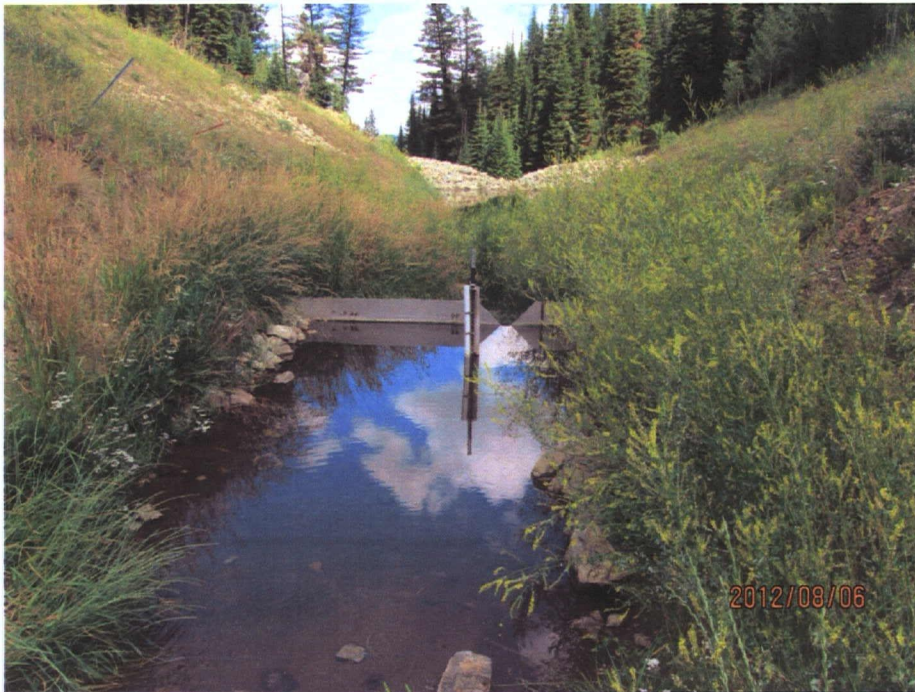
Photo taken looking north, showing the upper weir and the sediment control pond and structure. This photo shows great vegetation establishment and that the channel is in good condition.

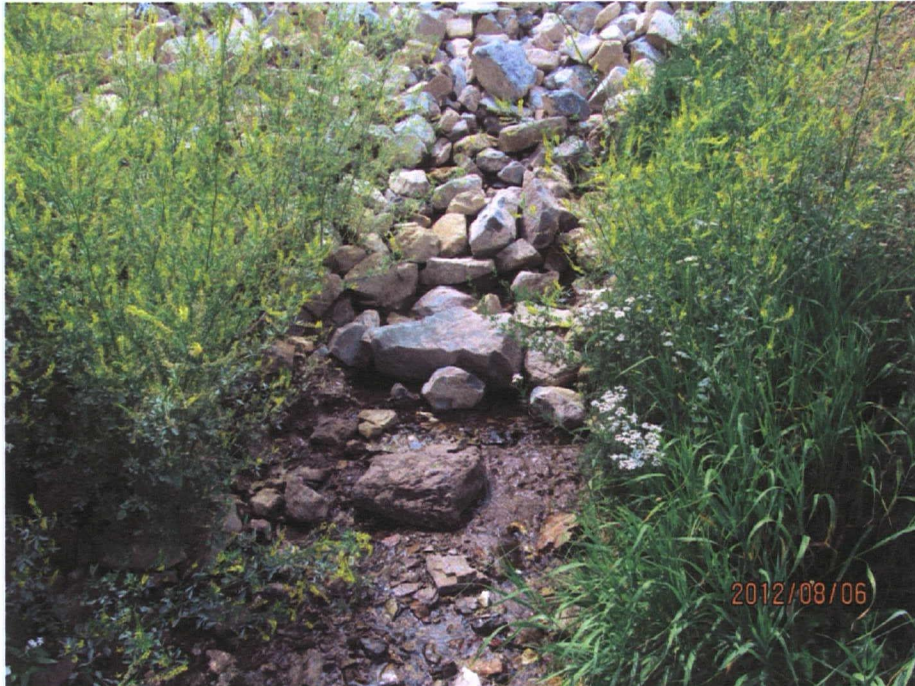
This photo is the toe of the riprap energy dissipater. Riprap armor is holding up well.

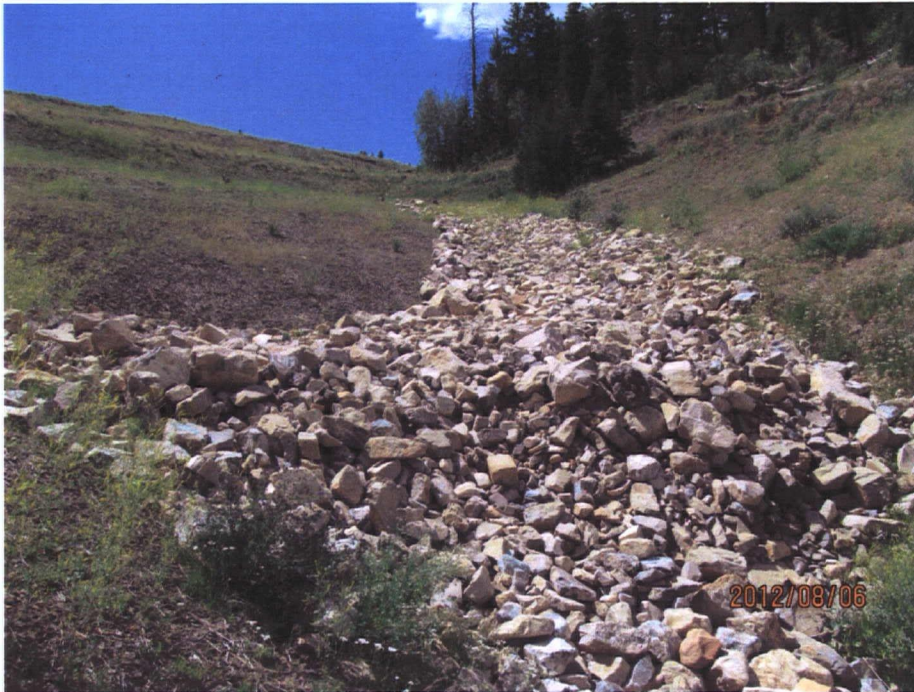
Photo taken looking south, showing the riprap lined channel below the upper culvert outfall. No sign of erosion is present.

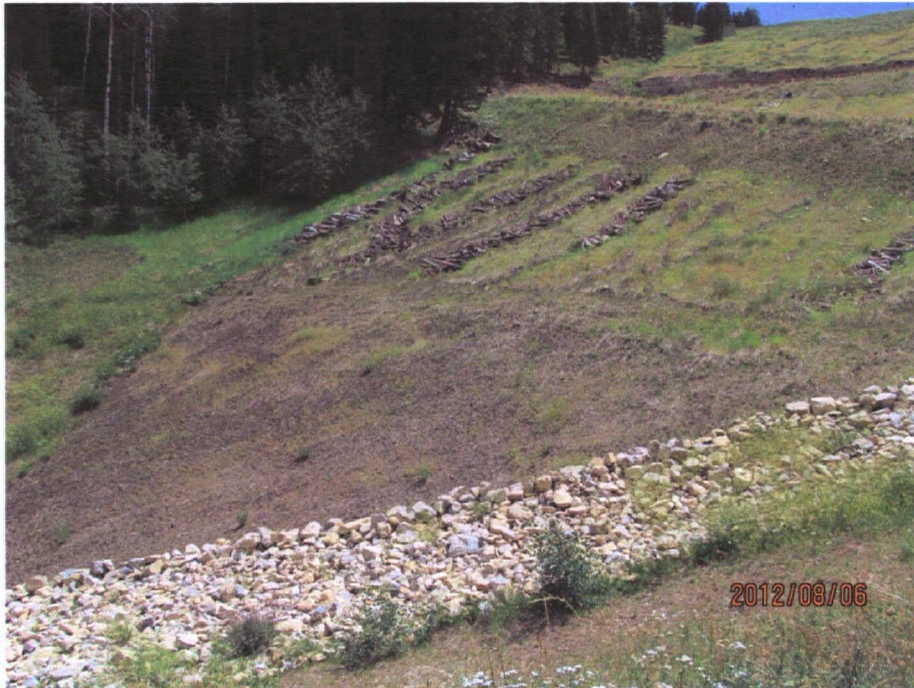
Photo taken looking southeast showing the logs in the rills on East Mill Dump and the riprap lined channel below the upper culvert outfall. No evidence of erosion is present.

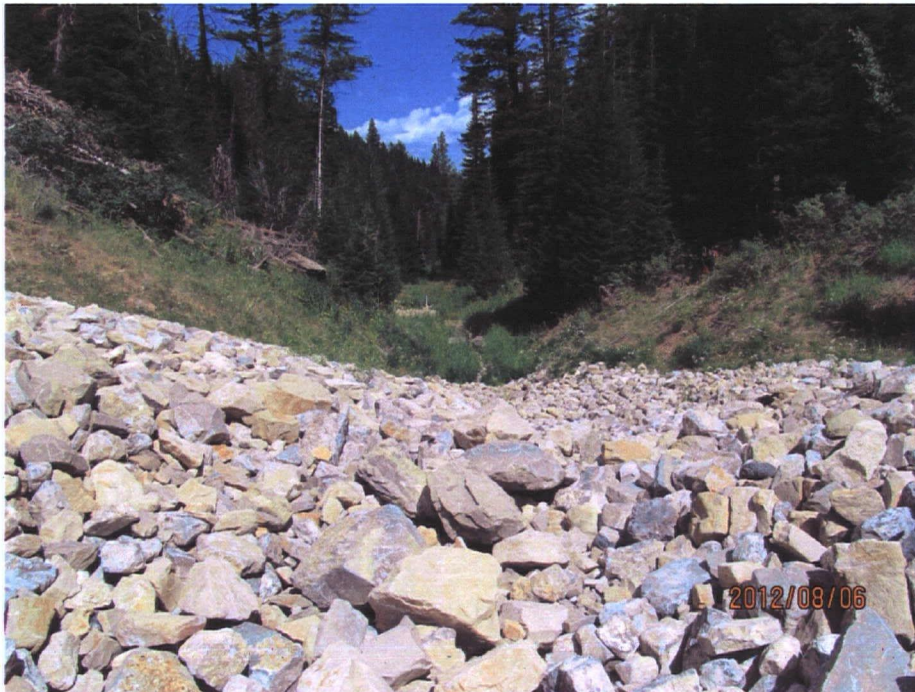
Photo taken looking north, from the top of the sediment control structure showing the lower weir and riprap lined channel below the sediment control structure.

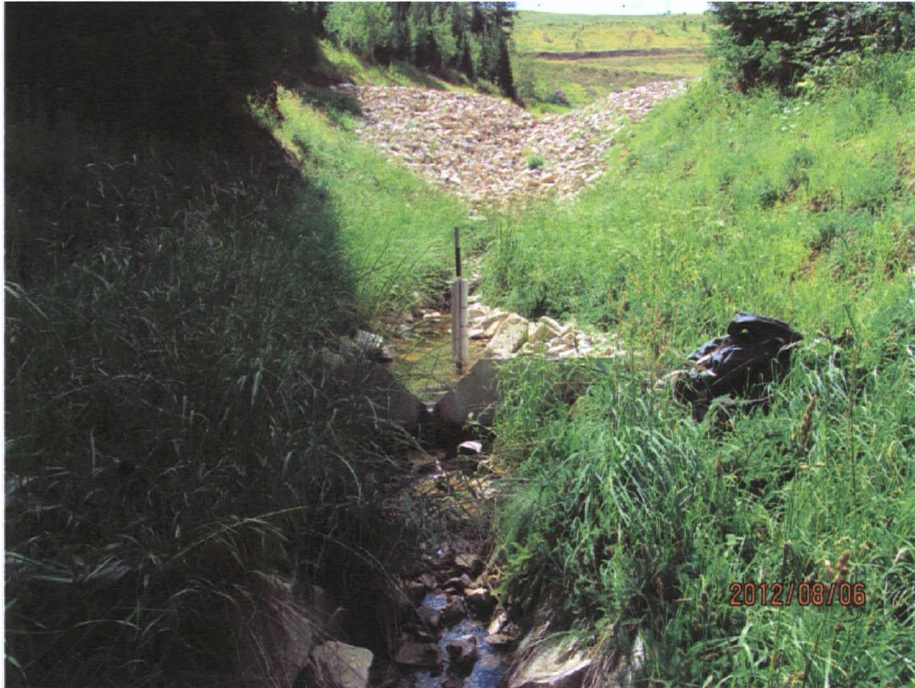
Photo taken looking south, showing a close up of the lower weir and riprap lined channel below the sediment control structure. This area is in good condition with vigorous vegetation established on side-slopes.
